NIST NCSTAR 1-5A

Federal Building and Fire Safety Investigation of the World Trade Center Disaster

Visual Evidence, Damage Estimates, And Timeline Analysis

(Chapter 9 - Appendix C)

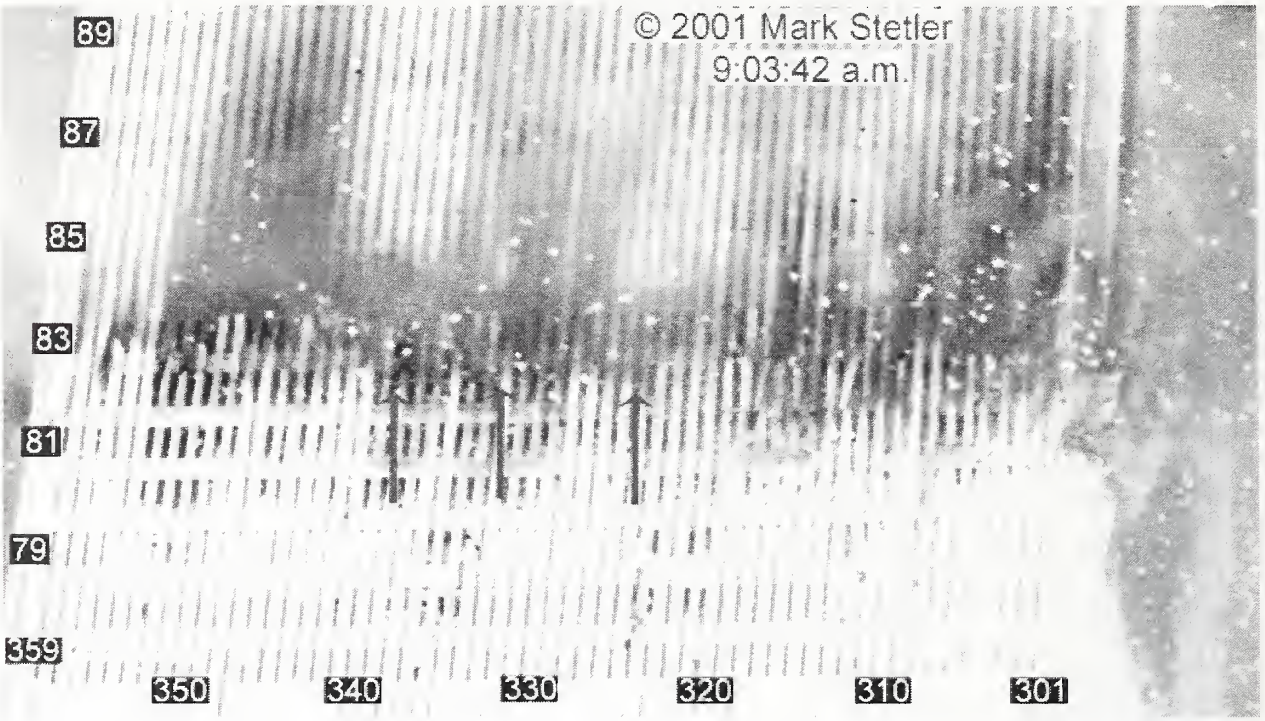
Figure 9–1 shows an image of the east face of WTC 2 recorded at 9:03:42 a.m., which was 43 s after the aircraft impact. The numerous white dots are pieces of paper that were expelled from the building due to the aircraft impact and subsequent fireballs. Extensive fires are visible on the 81st, 82nd, and 83rd floors. On the two lower floors, intense fires, which fill the windows with flame, appear to be nearly continuous from around windows 81-321 and 82-322 to the north edges of the floors. On the 83rd floor, the fires are intense, with considerable flaming outside of windows between windows 83-335 and 83-346. There is also a region with a lower intensity fire nearer the center of the face on the 81st floor, and there is an indication of a small fire near window 80-313 on the 80th floor. Despite the numerous fires present, the amount of smoke being released is relatively small, and it is possible to see most of the east face above the fires.

The intensity levels of the photograph in Figure 9–1 were adjusted to enhance the visibility of an object that is identified by the arrows added to the photograph. A blowup of the area of the photograph including the arrows is provided in Figure 9–2. The object appears as a narrow line that has been draped inside windows on the 82nd floor extending from at least window 82-321 to window 82-339. This hanging object will be observed numerous times in images to be shown below. While it is difficult to identify the object with certainty, the evidence will be strong that it is the end of a part of the 83rd floor concrete floor slab that has been dislodged from the spandrel located above the 82nd floor and has settled downward several feet to appear below the spandrel.

Figure 9-1. A view of the east face of WTC 2 recorded at 9:03:42 a.m. is shown. The original photograph has been rotated, cropped, and enhanced by adjusting intensity levels. Column and floor numbers have been added. The arrows highlight a hanging object observed through open windows on the 82nd floor.

Closer inspection of Figure 9–1 and Figure 9–2 shows that small flames are visible above the object at the tops of windows 82-335 to 82-337. While not as clear as in these windows, similar fires appear to be present elsewhere along the top of the line. Heavy flames are coming from windows on the 83rd floor immediately above this area. This suggests that the flames observed at the tops of windows on the 82nd floor are burning at the base of a fuel source located on top of the hanging object that is fueling the much larger flames visible on the 83rd floor. It is likely that this fuel is on top of the concrete floor slab that was originally attached to the spandrel above the 82nd floor.

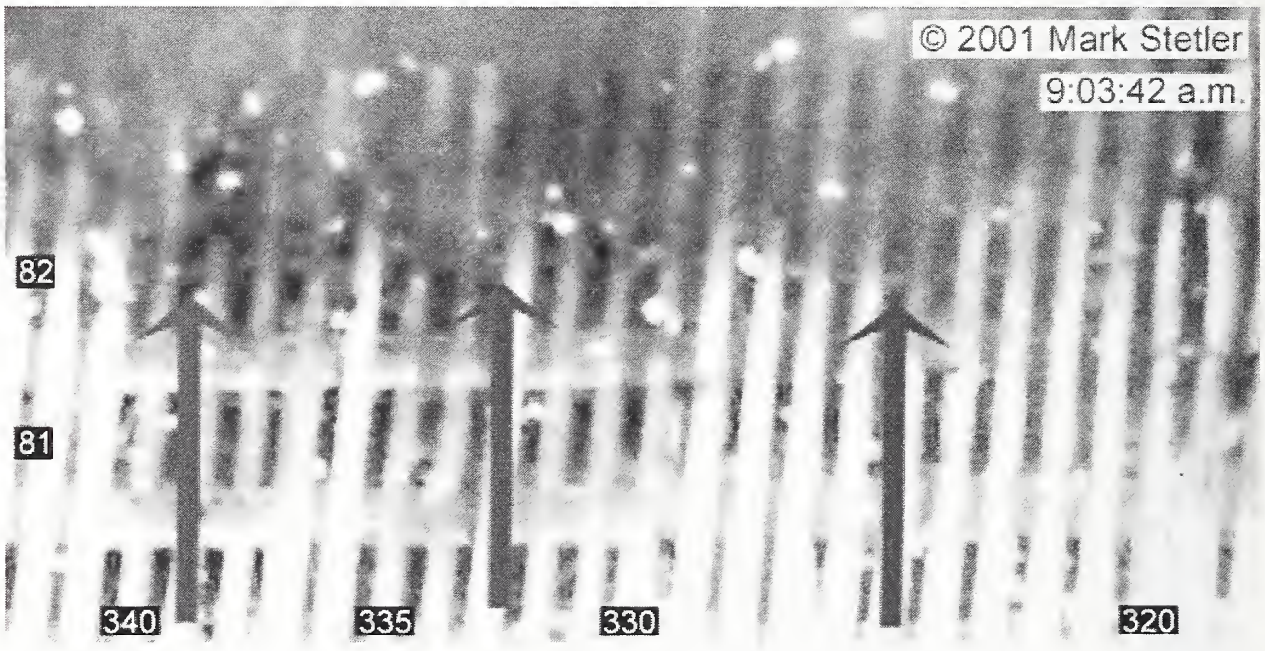
Figure 9-2. A section of the image shown in Figure 9–1 is blown up. The arrows point to the location of an object that is visible through open windows on the 82nd floor on the east side of WTC 2.

In Chapter 7 it was also noted that a substantial flash fire lasting several seconds occurred on the 82nd floor due to the release of aviation fuel. The sudden appearance of this fire is believed to have generated an overpressure, that may have been on the order of several psi on the floor (see the discussion in Section 6.5). This overpressure was likely responsible for the removal of large sections of the curtain wall on the north and east faces, and it drove additional atomized fuel from the building, resulting in the formation of fireballs. It is possible that the separation of the 83rd floor slab from the spandrel was due the generation of sufficient overpressure on the 82nd floor to push the 83rd floor slab upward off of its seats, allowing it to then settle down below the spandrel.

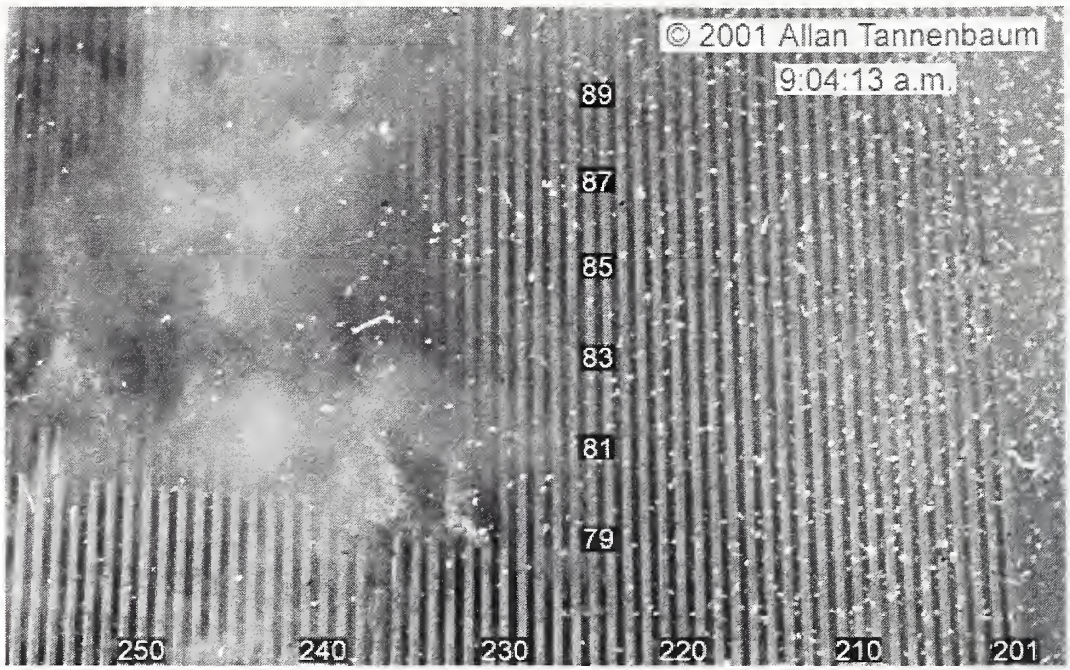
A view of the north face of WTC 2 recorded at 9:04:13 a.m. is shown in Figure 9–3. The large amount of paper expelled from the tower due to the aircraft impact and subsequent fires is apparent. Two areas of intense fire are seen. One of these is located near the east edge of the face on the 81st floor, and the second is on the 79th floor, extending from roughly windows 79-231 to 79-238. In Chapter 7 visual evidence was shown indicating that large piles of debris, presumably a mixture of aircraft and building debris, were present at these two locations. Evidently, these debris piles were ignited during the aircraft impact and subsequent fireballs and continued to burn intensely. Even though there is a large amount of dust evident, there does not appear to be a substantial fire in the region between the two burning areas.

Figure 9-3. This cropped photograph of the north face of WTC 2 was recorded at 9:04:13 a.m. The image intensity levels have been adjusted. Column and floor numbers have been added.

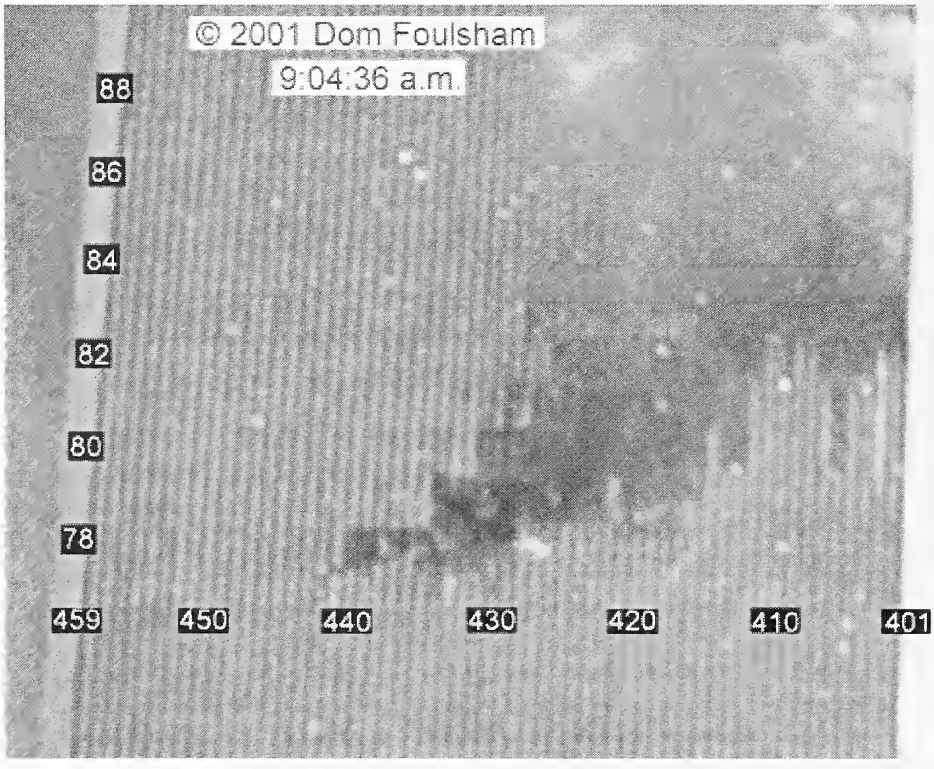
A view of the south face of WTC 2 recorded at 9:04:36 a.m. is shown in Figure 9–4. It was taken 97 s after the aircraft impact on this face. A number of sheets of paper are also visible on this side of the building. The most prominent feature is the damage caused by the aircraft impact. Two areas of bright flame are evident in the image on the 78th and 79th floors. On the 78th floor, the fire is located just to the right of the cavity generated by the aircraft impact, while on the 79th floor the fire appears to be burning within the cavity. On the 82nd floor there appears to be an orange glow from windows 82-420 to 82-425, suggesting that a fire is present in this area as well.

Figure 9-4. This cropped photograph shows the south face of WTC 2 at 9:04:36 a.m. Column and floor numbers have been added.

There is relatively little smoke coming from windows on the south face at this time. For later comparison purposes, note that the entire lengths of the 81st and 82nd floors can be seen and that very little smoke is evident coming from windows on these floors. The only significant plume of smoke is coming from the 83rd floor near the east edge of the face.

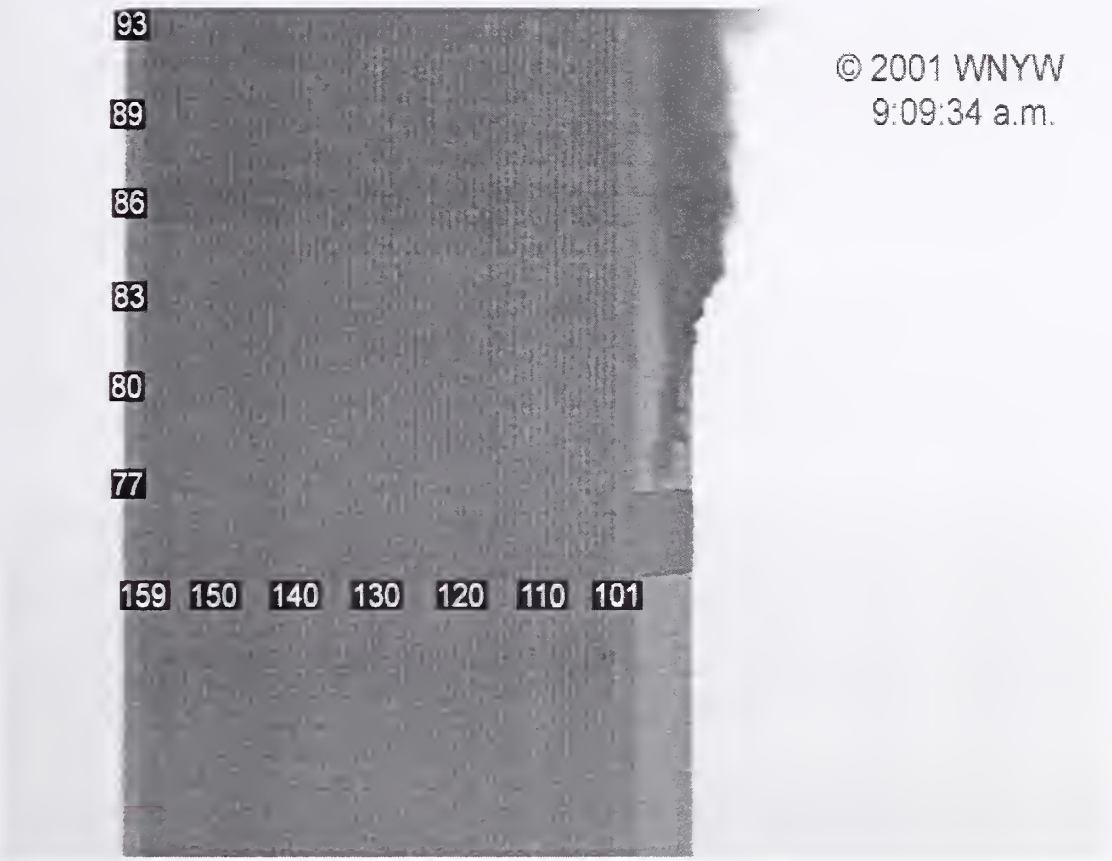
The database does not contain clear images of the west face of WTC 2 in the early period following the aircraft impact. Figure 9–5 shows an image of the face taken from a video recording made from a news helicopter at 9:09:34 a.m. At this time there was no visible smoke or fire on the face. This is consistent with the conclusion in Chapter 7 that the aircraft impact and subsequent fireballs caused no visible damage to the west face of WTC 2.

Figure 9-5. This image of the west face of WTC 2 was captured from a video shot from a news helicopter at 9:09:34 a.m. Column and floor numbers have been added.

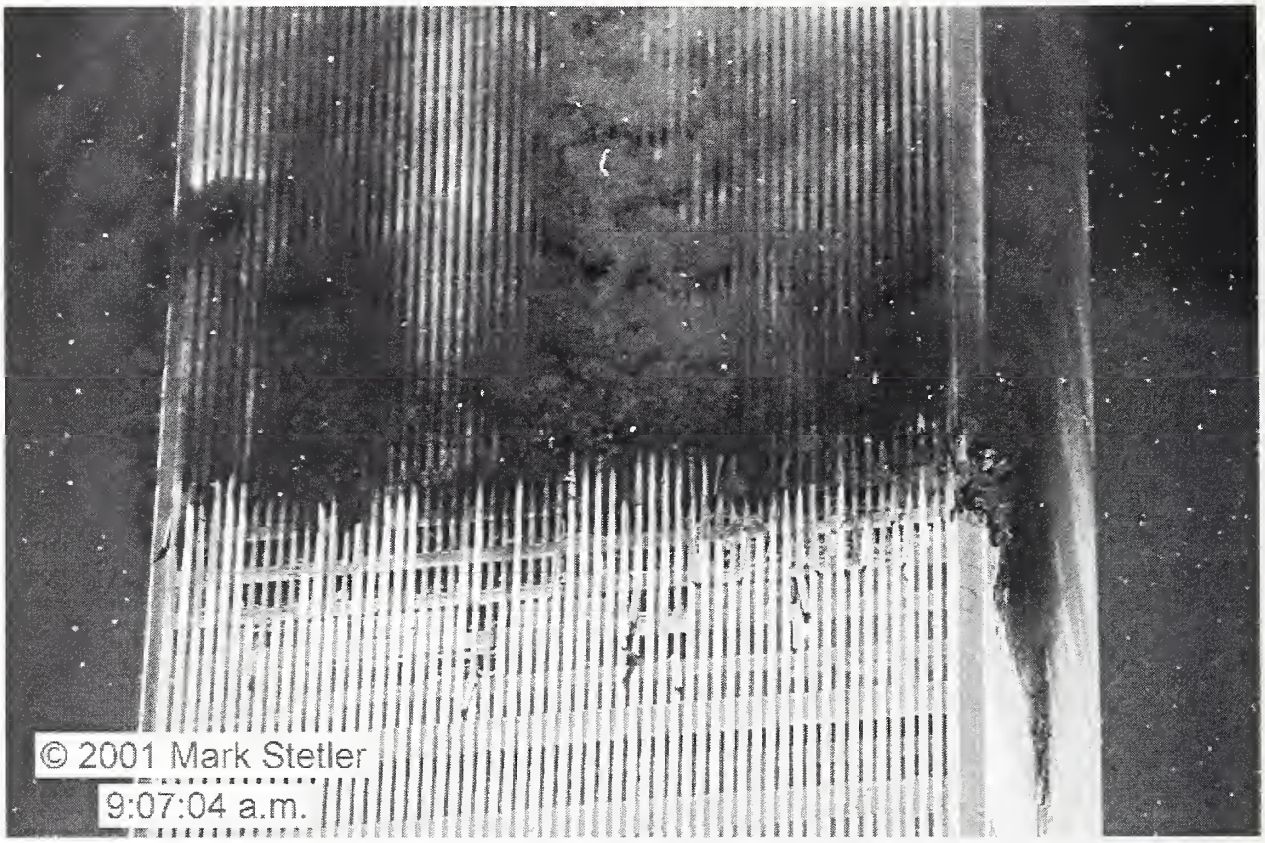
Figure 9-6. This photograph showing the east face of WTC 2 was recorded at 9:07:04 a.m.

A close-up view of the east face of WTC 2 recorded at 9:07:04 a.m. is shown in Figure 9–6. During the 3 min 20 s since Figure 9–1 was taken, the fire distribution on the face has changed. The large fires that were burning earlier on the 81st, 82nd, and 83rd floors appear to have died down somewhat. A new area of intense fire has appeared on the 82nd floor just to the south of where the large fire was visible on the 83rd at the earlier time.

A substantial increase in the amount of smoke coming from open windows is evident when the two photographs of the east face are compared. The smoke appears to be coming from two separate locations on the 82nd floor. Videos of the east face show that heavy smoke appeared first from the area on the south side of the face, increasing rapidly around 9:04:30 a.m. The smoke flow coming from windows just to the north of the center of the face increased markedly about 50 s later.

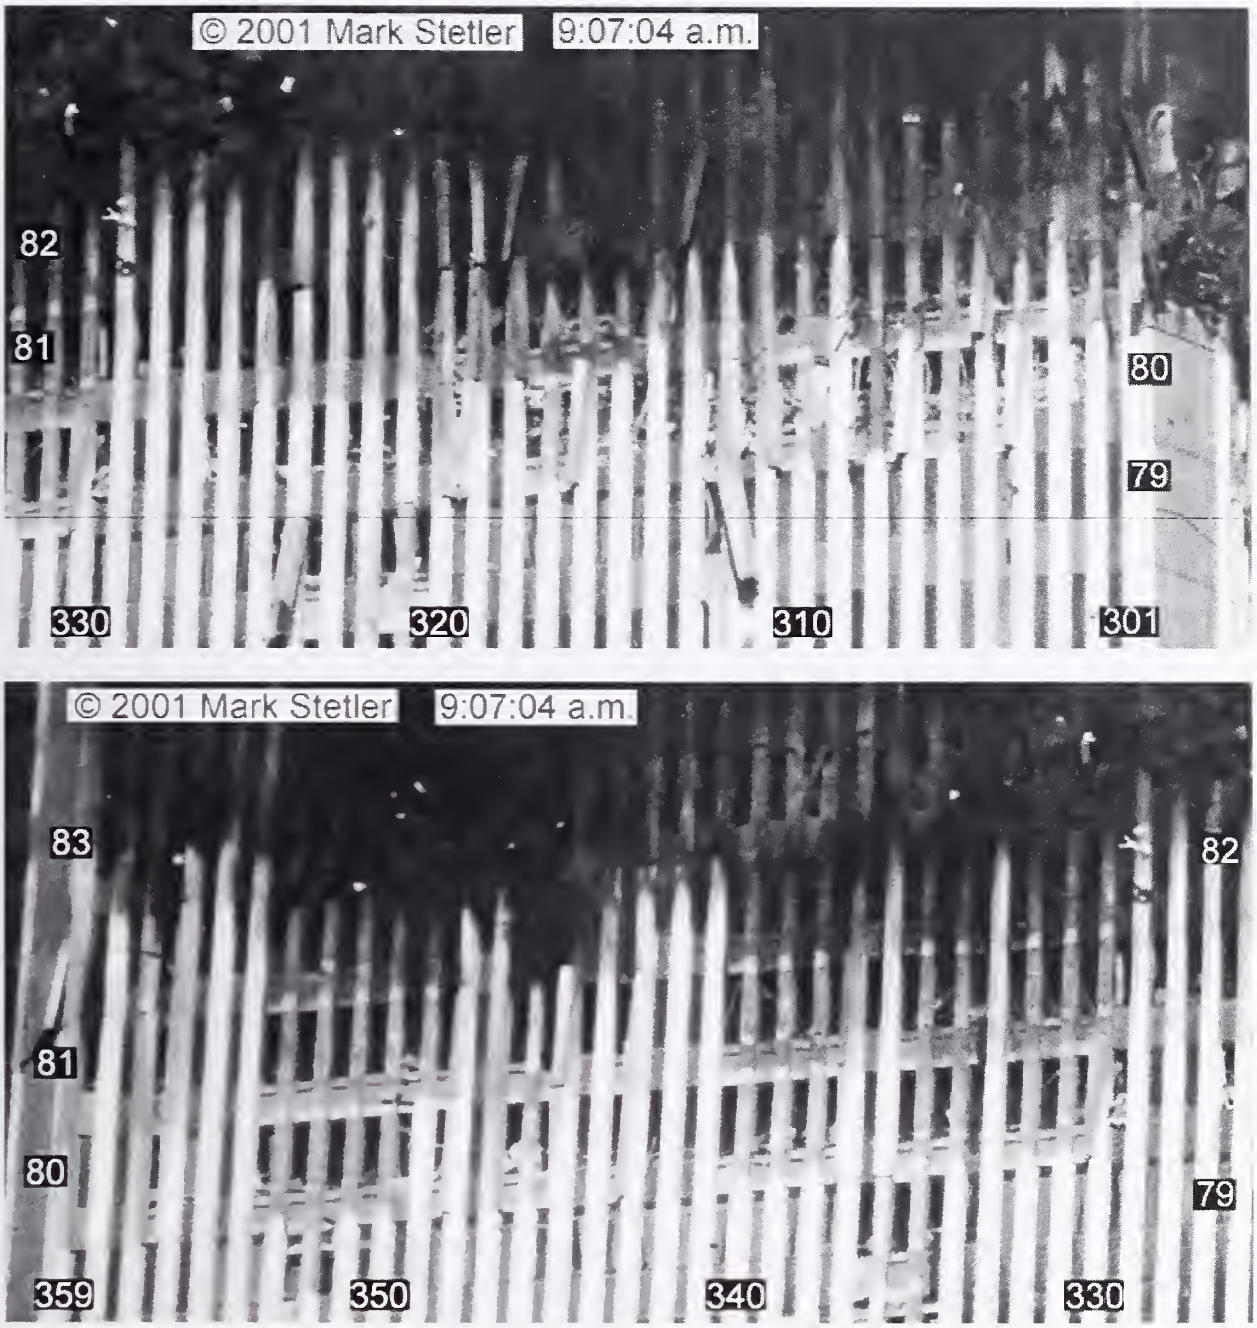
The image in Figure 9–6 provides a great deal more resolution than is evident from the way it has been sized. Figure 9–7 shows blowups taken from the photograph of the northern and southern halves of the east face for the floors where fires were present. The north side is at the top of the figure. In this image the damage to the aluminum façade is evident. The debris that has been piled along the east wall in the northeast corners on the 80th and 81st floor is visible. There is also a large amount of debris protruding from the opening created by removing the aluminum panel from the northeast corner of the 81st floor.

Figure 9-7. These two images show blowups of the north and south sides of the east face of WTC 2 taken from the photograph included in Figure 9–6, which was shot at 9:07:04 a.m. Column and floor numbers have been added.

Heavy fires are burning in the northeast corners of the 81st and 82nd floors. On the 81st floor flames are coming from windows 81-301 to 81-304 as well as from the northeast corner where the aluminum panel has been removed. Lower intensity flames are evident in many windows further to the south, extending at least as far as the last visible window, 81-332. It is likely that the fire is continuous across this entire length. On the 82nd floor flames are coming from windows 82-301 to 82-309. Flames further to the south do not appear to be as widespread as on the 81st floor, but there is much more smoke coming from open windows on this floor. The smoke flow is particularly heavy from windows 82-323 to 82-332. The

A blowup of the southern side of the fire floors is included at the bottom of Figure 9–7. Flames are visible on the 83rd floor over a length from near window 83-331 to window 83-338. The intensity of these flames has died down considerably from that observed at the earlier time in Figure 9–1. It can be seen that a considerable amount of the aluminum facing on this floor has been removed.

On the 81st floor the last window to the south where a low-intensity fire is observed is window 81-333. It is interesting that despite the fact that there is a great deal of damage to the aluminum façade on this floor, there are several windows for which the glass is still in place. The small spot fire present in window 80-330 can be seen in the overlapping lower image as well. Several window panes are also still in place on this floor. No fire or smoke is visible on this half of the 79th floor.

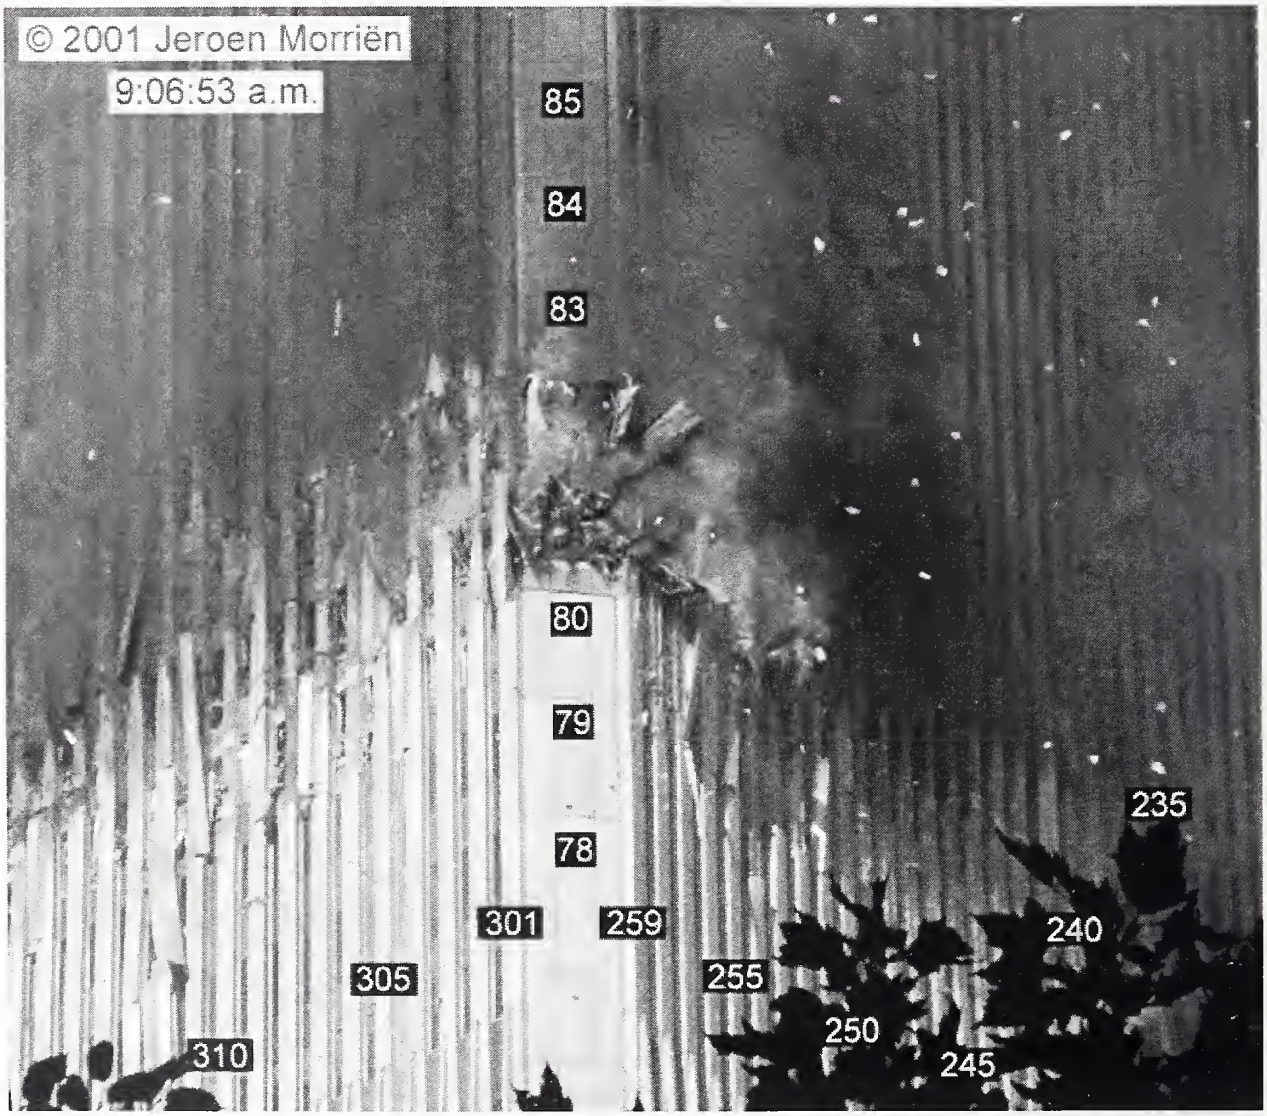
An image of the fires on north and east faces shot from the northeast at 9:06:53 a.m. is shown in Figure 9–9. It provides a good view of the debris that was protruding from the northeast corner of the 81st floor, as well as an indication of the actual extent and intensity of the fires burning in the northeast corners of the 81st and 82nd floors. The cold spot on the north face is easily identified from this angle.

Figure 9-9. This cropped photograph showing the northeast corner of WTC 2 was taken at 9:06:53 a.m. The image has been enhanced by adjusting the intensity levels. Column and floor numbers have been added.

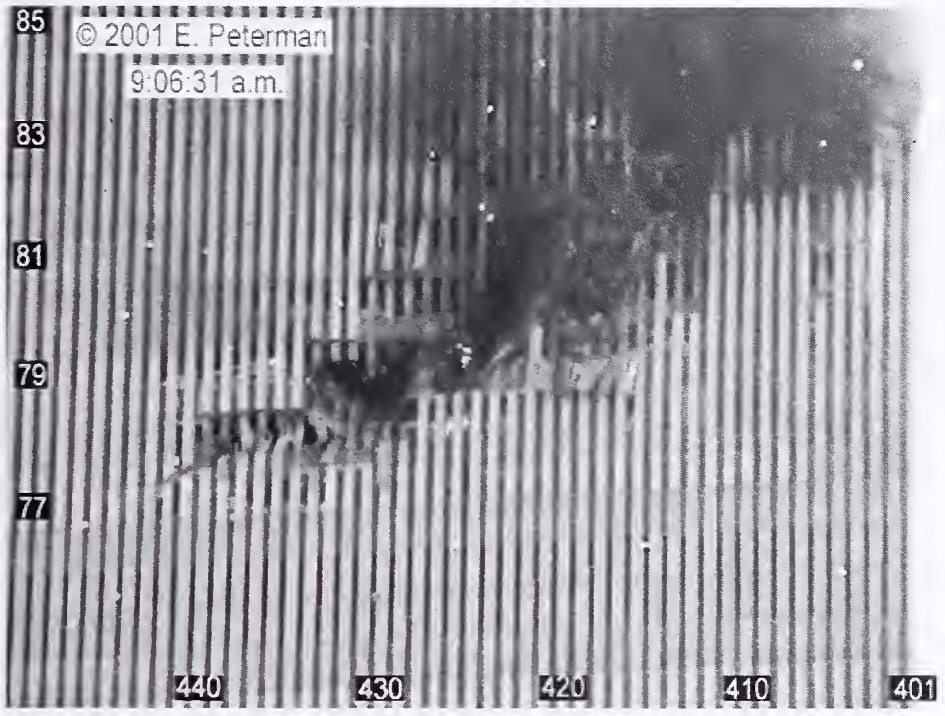
An image of the south face of WTC 2 taken from a video recorded at 9:06:31 a.m. is shown in Figure 9–10. This is slightly less than two minutes later than the image shown in Figure 9–4. Even though the latter image is clearer and shows more detail, it can still be seen that the appearance of the face has changed somewhat during this short period. A new fire has appeared on the 81st floor near window 81-430 that was not apparent earlier. The fire that was burning within the cavity created by the aircraft impact on the 79th floor seems to have moved toward the west and can now be seen on top of a pile of debris through open window 81-436, as well as at multiple locations on the debris within the impact cavity. In the later image there is no indication of a fire burning on the 82nd floor above the aircraft impact cavity.

In Figure 9–10, smoke is coming from open windows to the east of the aircraft impact cavity on the 81st floor, and there is an indication of flames in the area. In the earlier photograph, this area was clear of smoke, and some details on this floor as well as the one above could be identified. Apparently, a fire has grown quickly on the 81st floor in this area. Interestingly, a photograph of the east face taken around this time (see Figure 9–7) shows very little smoke and no visible flame near the south edge of the face. This suggests that the fire growing at this location was ignited near the aircraft impact location and is moving toward the east.

Figure 9-10. This image showing the south face of WTC 2 is a frame captured from a video recorded at 9:06:31 a.m. It has been enhanced by adjusting the intensity levels, and column and floor numbers have been added.

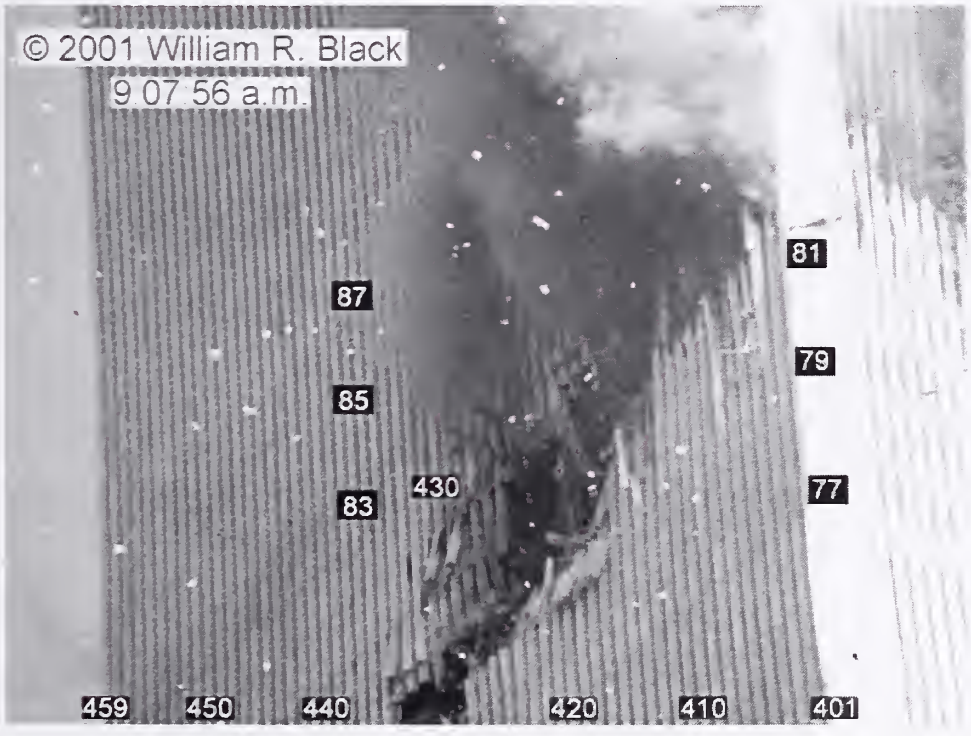
Another view of the south face at roughly the same time is shown in Figure 9–11. It was shot from further east than Figure 9–10. From this angle fires are visible at multiple spots inside the aircraft impact cavity, including locations corresponding to the 78th, 79th, and 80th floors. The smoke coming from the windows to the east of the aircraft impact cavity on the 81st floor is also visible. Apparently, the fires

Figure 9-11. This photograph of WTC 2 was taken at 9:07:56 a.m. from the southeast and shows the south face and a portion of the east face. The intensity levels have been adjusted, and column and floor numbers have been added.

growing on this floor are also venting through the aircraft impact cavity since a large amount of smoke is flowing from the opening just to the west. This photograph confirms that little smoke and no flames are visible coming from windows on the 81st floor of the east face that are adjacent to this area.

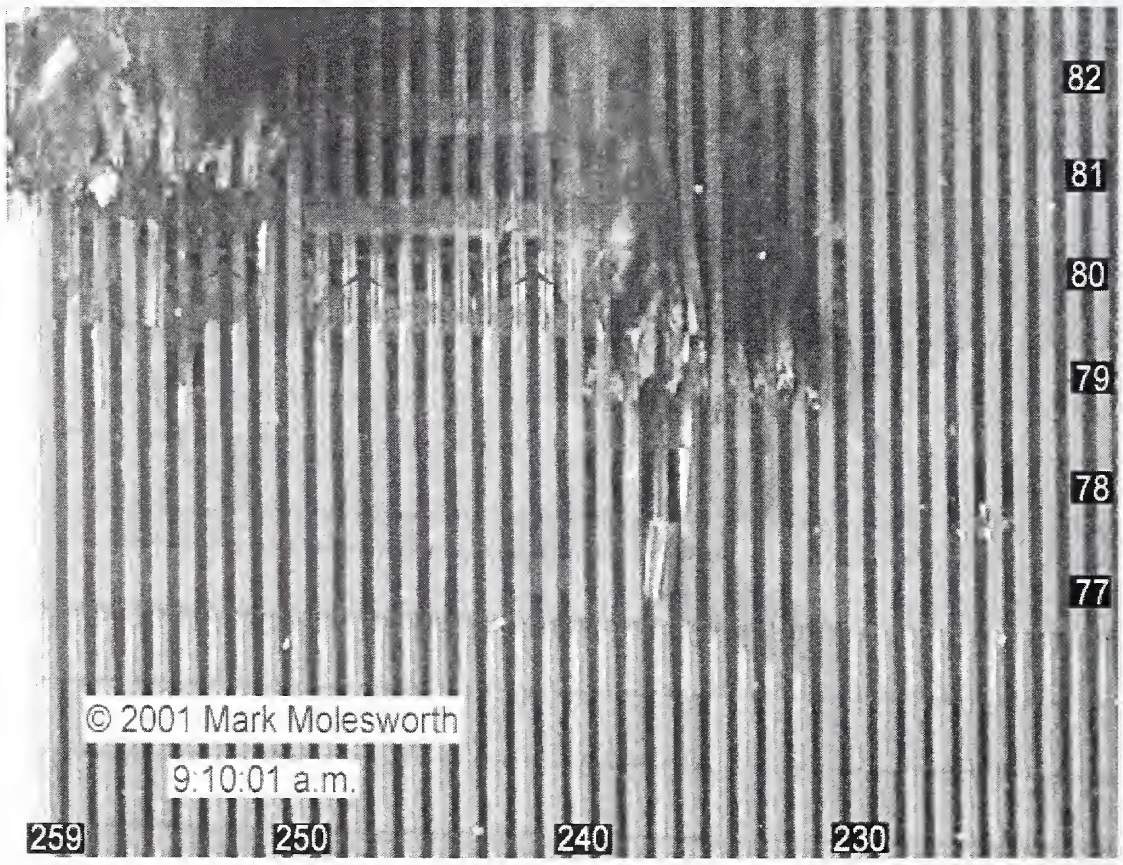
At 9:10:01 a.m. a videographer recorded a closer view of the north face of WTC 2 than those presented thus far. Figure 9–12 shows a frame captured from this video. The image shows that the fires burning on the 79th, 80th, and 81st floors have not changed markedly since 9:07:23 a.m. (see Figure 9–8). The cold spot is also distinct. The increased resolution of Figure 9–12 allows a detail to be resolved that was not easily identified in the earlier images. There appear to be two objects hanging across a length of open windows on the 80th floor. The arrows added to the image indicate these objects. One of the objects appears as a line running from at least window 80-255 to window 80-243. The second object also appears as a curved line. It is visible above the first object starting near the top of window 80-247 and extending west to at least window 80-241.

Figure 9-12. An image of the north face of WTC 2 captured from a video recording at 9:10:01 a.m. is shown. The intensity levels of the image have been adjusted, and column and floor numbers have been added. The arrows highlight hanging objects observed through open windows on the 80th floor.

Closer inspection of Figure 9–12 shows that flames are visible above the first object in windows 80-249, 80-252, and 80-253. These fires have similar locations and appearances to the numerous fires that were observed at the tops of windows in WTC 1 (see Chapter 8) and were attributed to burning thermal insulation located above the windows. In this case this explanation seems unlikely since the aluminum façade has been removed from the columns adjacent to these windows. Using Figure 9–12 as a guide, Figure 9–8 was reviewed more carefully to look for indications of these objects and fires. It is possible to barely discern the first of the objects, and the fires above the objects are clearly visible at the earlier time.

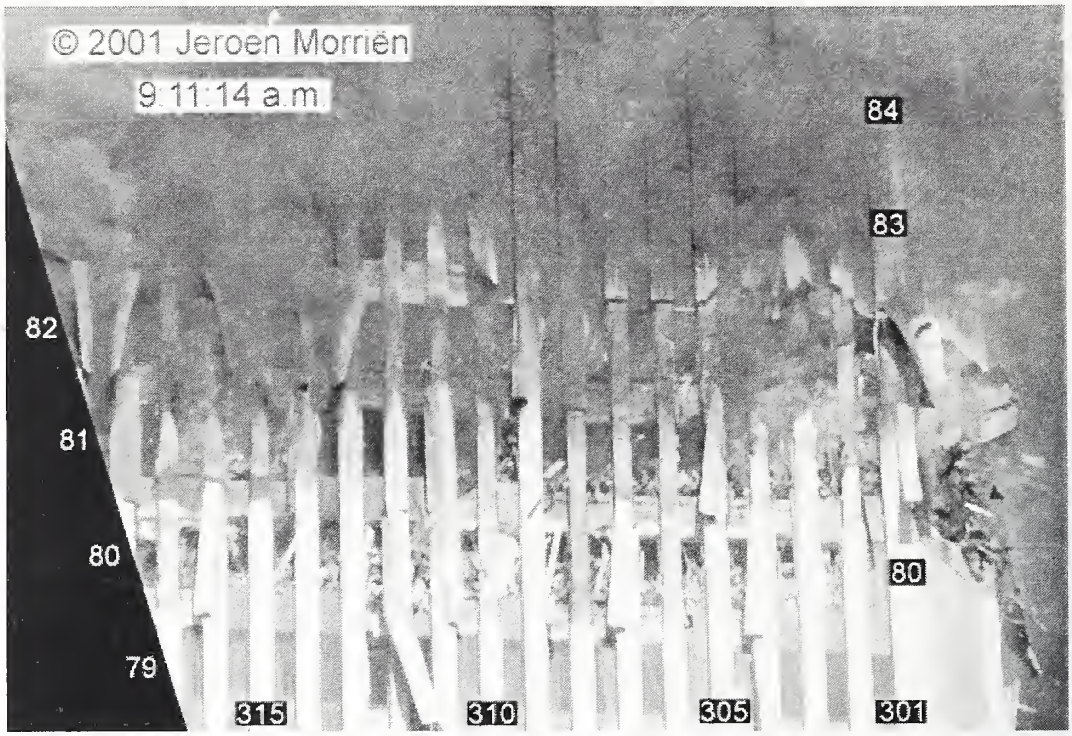
A close-up view of the northern portion of the east face of WTC 2 at 9:11:14 a.m. is shown in Figure 9–13. The debris piles on the 80th and 81st and in the opening on the northeast corner of the 81st floor are particularly clear. The fires on the 81st and 82nd floors continue to burn intensely. The only fire visible on the 80th floor is in window 80-317. Most of the glass is intact for windows on the 79th floor.

Figure 9-13. This photograph shows the northern portion of the east face of WTC 2 at 9:11:14 a.m. The image has been cropped and rotated, and the intensity levels have been adjusted. Column and floor number have been added.

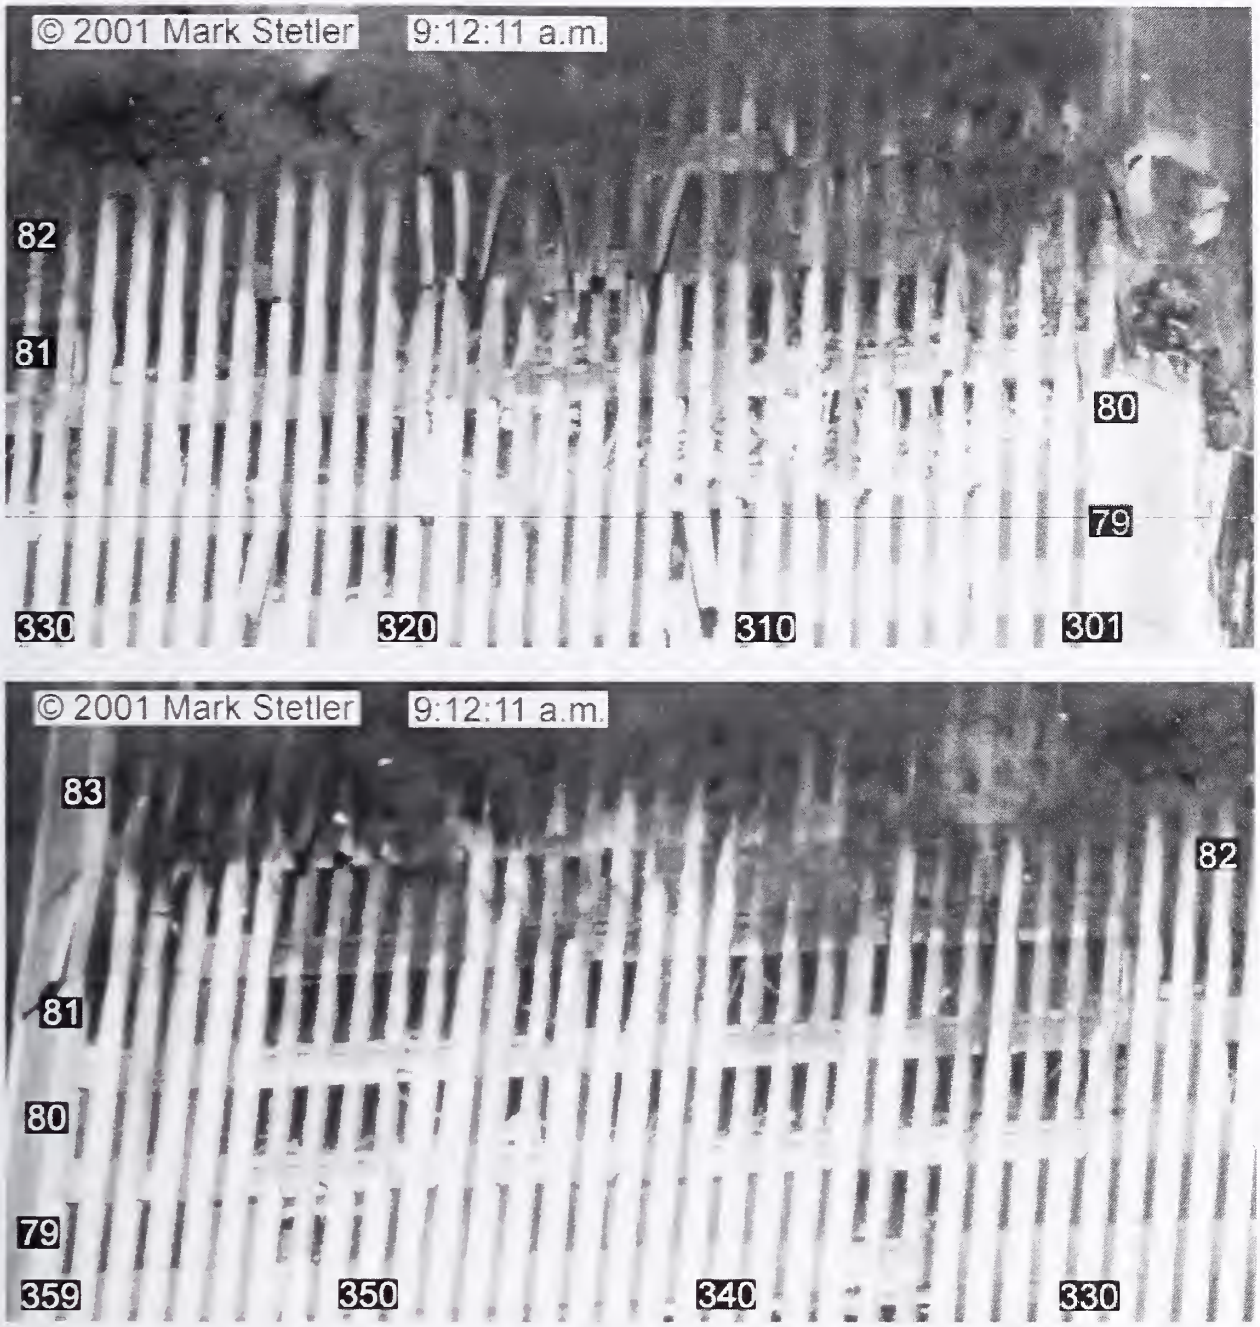
Another photograph of the east face of WTC 2 taken at 9:12:11 a.m. is shown in Figure 9–14. Figure 9–15 includes blowups of the north and south sides of the fire floors from this photograph. Comparison of Figure 9–14 with the similar photograph in Figure 9–6, which was taken just over 5 min earlier, shows that the heavy smoke flows from near the center and closer to the southern edge of the face have continued. In Figure 9–14, it appears as if a portion of the smoke flow near the center may be coming from the 83rd floor. It can also be seen that the fire burning on the southern half of the 81st floor has grown substantially.

Figure 9-15. These two images show blowups of the north and south sides of the east face of WTC 2 taken from the photograph included in Figure 9–14, which was shot at 9:12:11 a.m. Column and floor numbers have been added.

The fire spread during the period is more easily characterized by comparing the blowups of the southern part of the face shown in Figure 9–7 and Figure 9–15. At the earlier time, flames were visible on the 82nd floor in windows 82-341 to 82-349. By 9:12:11 a.m., the flames had spread to cover a length of the floor, running from window 82-332 to window 82-350. At the earlier time, smoke was coming from some of the windows where fire has now appeared. This is likely an indication that growing fires were near these windows at 9:07:04 a.m. As the fires to the north have grown larger, the earlier fires in windows 82-341 to 82-349 have decreased in intensity, as reflected by their external flame lengths. This

The close up views of the north side of the east face shown at the tops of Figure 9–7 and Figure 9–15 look very similar. There appears to have been a slight decrease in the intensity of the fires burning in the northeast corners of the 81st and 82nd floors. Two small spot fires burning on the 80th floor also seem to have grown smaller.

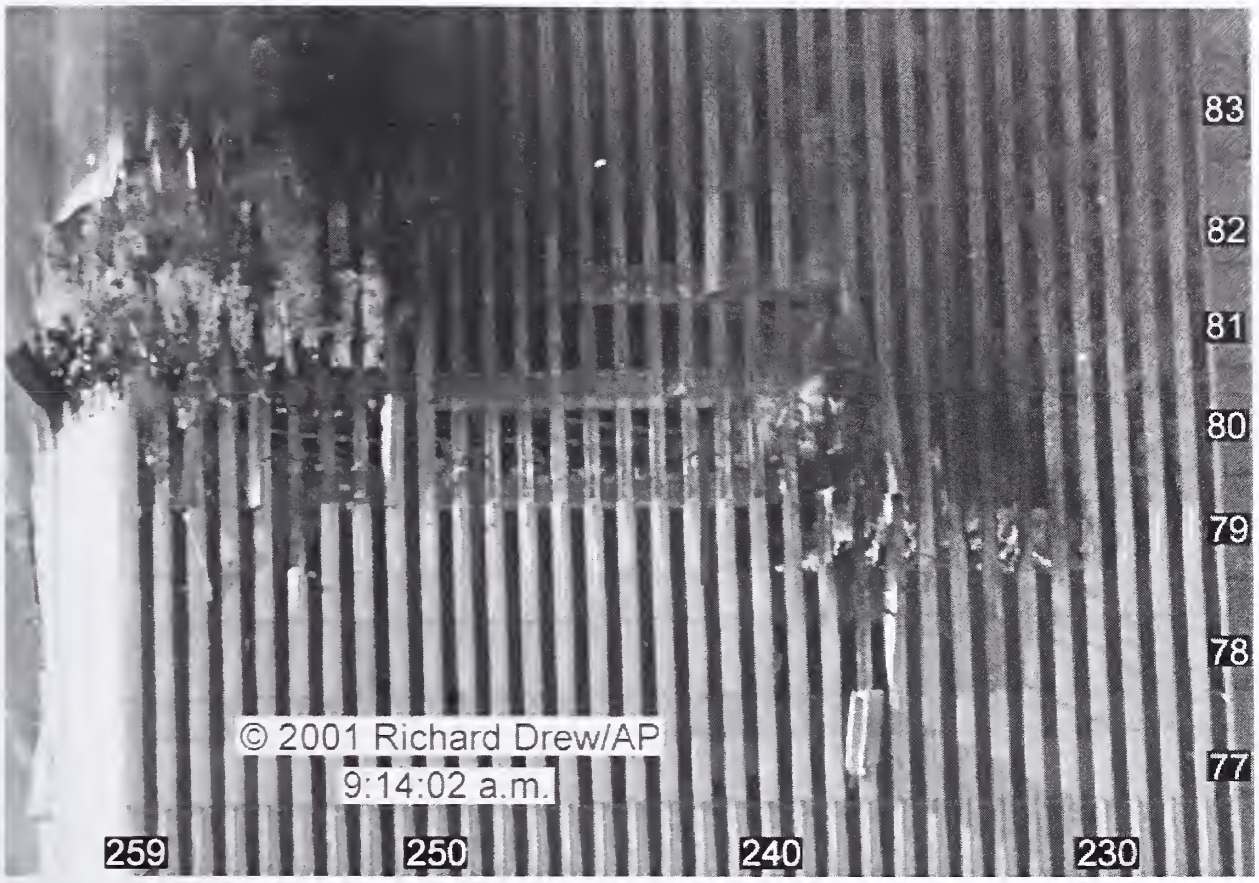
Even though the later image has higher resolution and shows more detail, a comparison of Figure 9–12 and Figure 9–16 indicates that the locations of the hanging objects identified in Figure 9–12 have not shifted appreciably during the 4 min period between the photographs. There are additional hanging objects resolved in the later photograph (seen most clearly in Figure 9–17) that are not easily identified in Figure 9–12. In addition to the two hanging objects on the 80th floor that were previously described, there is another similar object visible on the 81st floor near the tops of windows 81-239 to 81-242. This hanging object appears to consist of two closely spaced lines. There is yet another object in windows 80-251 to 80-254 that is below the much longer object that is visible hanging across window 80-242 to window 80-256.

In Figure 9–16 and Figure 9–17, small fires are visible above the longest hanging object seen through windows on the 80th floor at the tops of window 80-248 and windows 80-252 to 80-254, again suggesting that fuel located on top of the hanging objects is burning. The large fires nearest the eastern edge on the 81st and 82nd floors and in the opening on the northeast corner continue to burn intensely in the same windows as earlier. In Figure 9–16, it appears as if a fire is burning on the 83rd floor in window 83-257, but it is possible that these flames are an extension from the large fire on the 82nd floor. There is evidence in the photograph for strong heating of the façade at the base of the 83rd floor in this area. The lower portions of the aluminum covers on columns 83-256 to 83-259 are missing, and the bottom edges of the remaining aluminum have an inverted "v" shape. These observations indicate that these aluminum column covers have been melted by the intense heat coming from below.

Figure 9-16. This close-up image of the north face of WTC 2 was taken at 9:14:02 a.m. The original photograph has been cropped and rotated, and the intensity levels have been adjusted. Column and floor numbers have been added. The arrows highlight hanging objects observed through open windows on the 80th and 81st floors. The brown area to the right is the eastern edge of WTC 7.

Most of the cold spot continues to be smoke and fire free. In the lower right-hand corner of the area a small fire is now visible on the 80th floor in windows 80-238 to 80-240, burning on a debris pile. The image in Figure 9–16 has sufficient resolution to determine the condition of windows. All of the windows on the 83rd floor immediately above the cold spot have glass in place while windows 79-241 to 79-249 on the 79th floor below the spot were also closed at this time.

The debris pile on the 79th floor continues to burn vigorously. Comparison of Figure 9–12 and Figure 9–16 shows that flame lengths are decreasing slowly. This fire is visible in the same windows as earlier and does not appear to be spreading in either direction along the north side of the building.

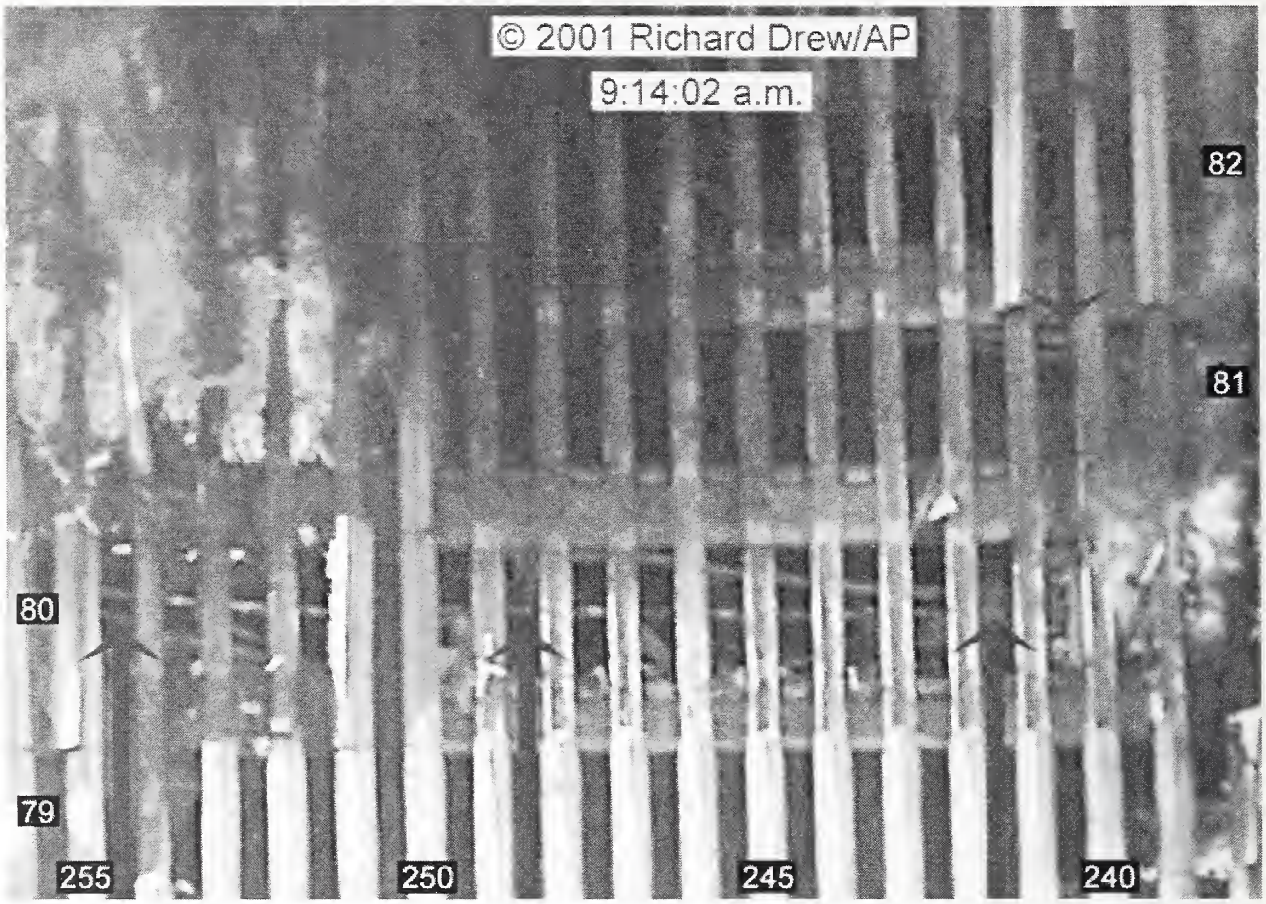
Figure 9-17. A section of the image shown in Figure 9–16 is blown up. The arrows point to the locations of hanging objects that are visible through open windows on the 80th and 81st floors on the north side of WTC 2.
